THE RENSSELAER COUNTY
SOLDIERS AND SAILORS
MONUMENT
MONUMENT SQUARE, TROY, NEW YORK

EXISTING CONDITIONS
ASSESSMENT

May 2017

John G. Waite Associates, Architects PLLC
384 Broadway, Albany NY 12207
64 Fulton Street, Suite 402, New York, NY 10038

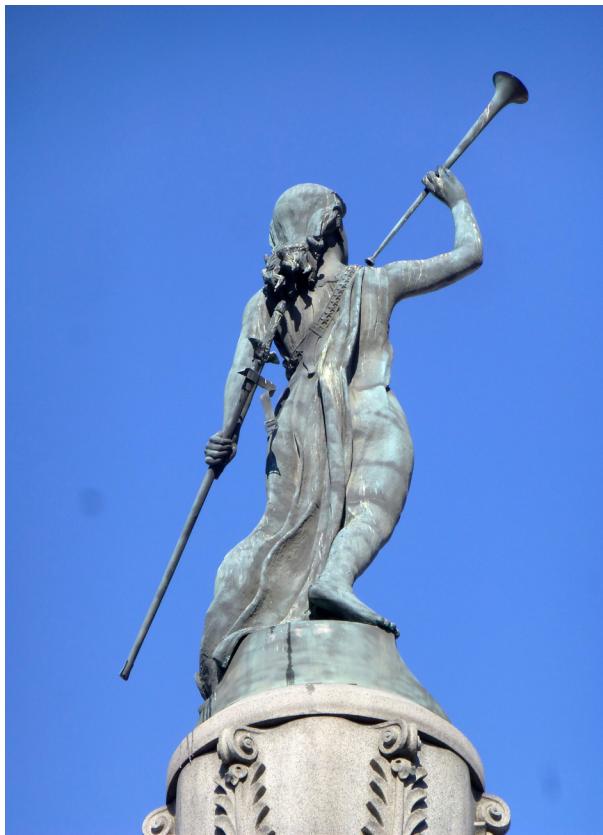
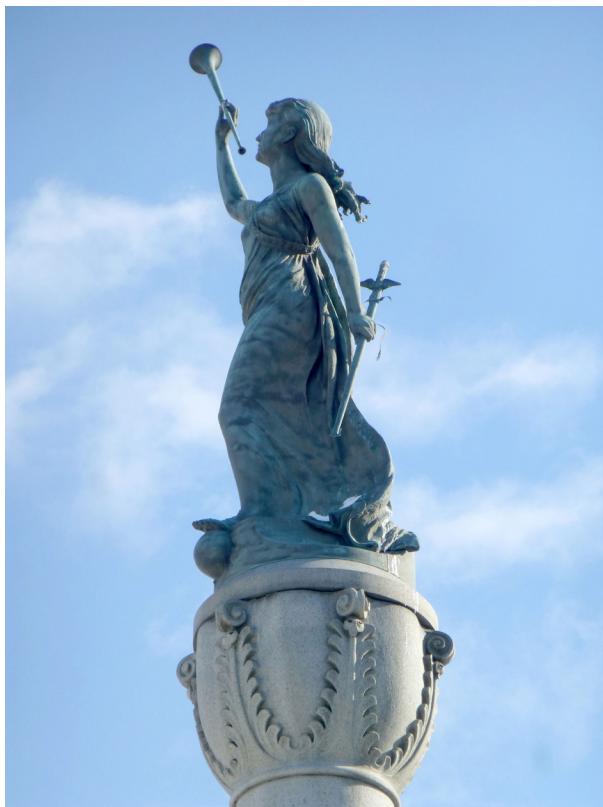
A Call to Arms may have last been cleaned and coated with a protective layer of wax in 1950, when the monument was transferred from The Rensselaer County Soldiers and Sailors Monument Association to the ownership of the City of Troy. She exhibits no outward signs of significant deterioration, but the uneven color of the statue's surface represents mild corrosion of the metal surface. JGWA, 2017.

- The bronze statue and eight bronze plaques should be cleaned using the gentlest means possible, so as to remove only damaged protective coatings, and not the existing patina. Abrasives and chemicals should be kept to a minimum, if they are used at all. This work should be performed by a firm that specializes in the conservation of outdoor bronze sculpture. **\$55,000**

- All of the bronze should receive a protective coating of microcrystalline wax. This work should be performed by a firm that specializes in the conservation of outdoor bronze sculpture. **\$22,000**

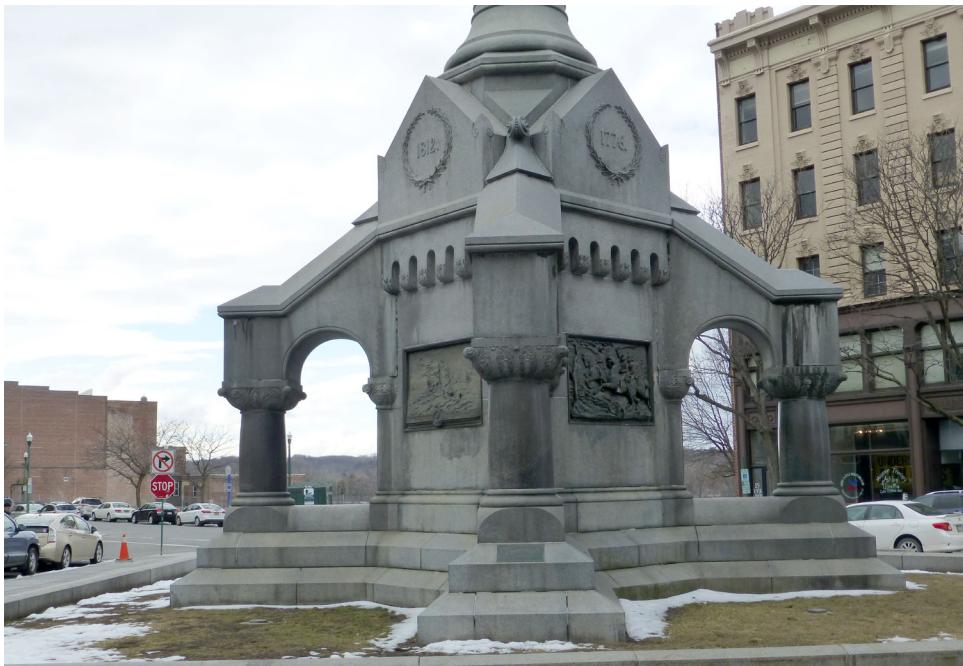
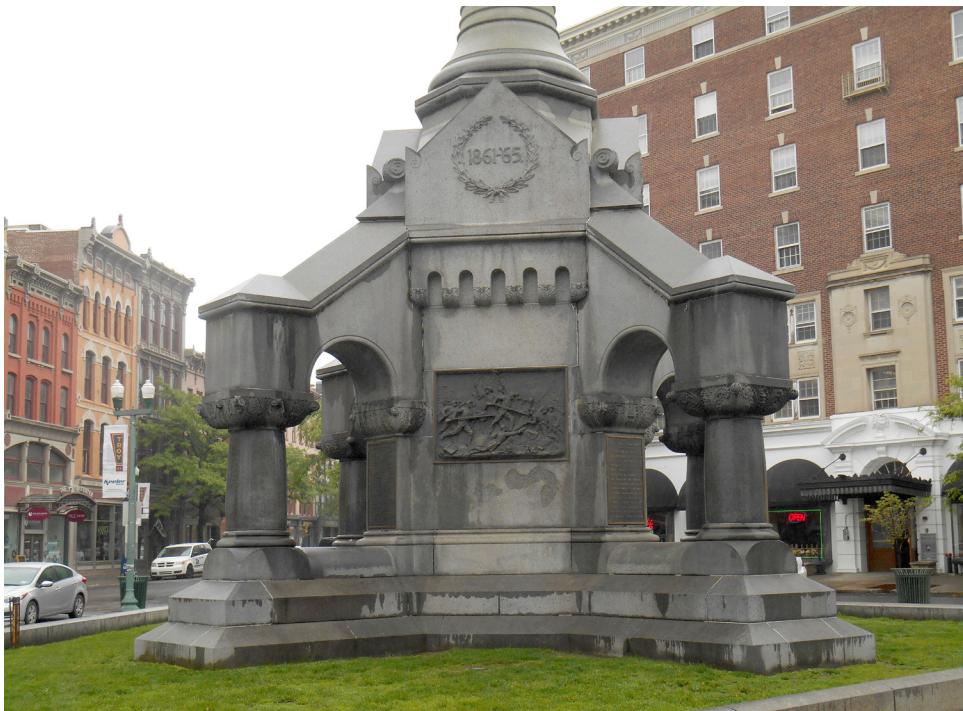
The monument's Romanesque base is made up of a relatively small number of large blocks of carved Quincy granite from Massachusetts. The base also incorporates polished granite column shafts, as well as eight bronze plaques cast by the Henry-Bonnard Bronze Co. in New York City. Four of these plaques are highly detailed pictorial alto-relief panels. The remaining four smaller plaques contain only writing. A ninth plaque, on the east side of the monument, commemorates the monument's cornerstone laying, dedication, and the board that oversaw the project. JGWA, 2017.

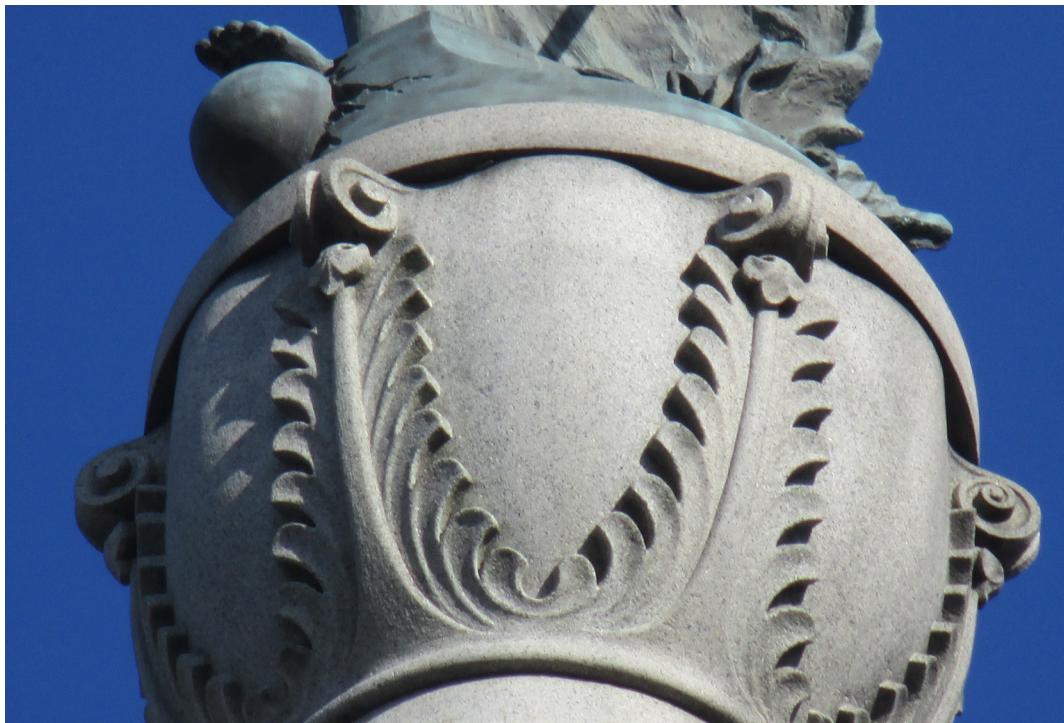
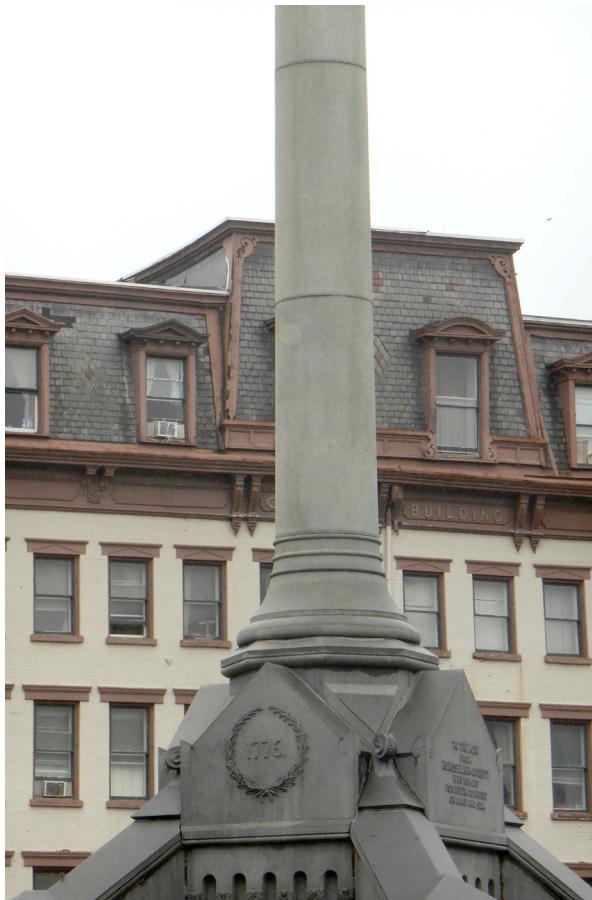
Between the monument's base, which the public experiences at close range, and the statue that resides far overhead is a tall granite shaft and an unusual, but carefully carved, granite capital that acts as a base for *Call to Arms*. Like the vast majority of the monumental blocks of stone used in the construction of the monument, the shaft and capitol are in good overall condition, with only open mortar joints and minor staining from environmental pollutants. JGWA, 2017.

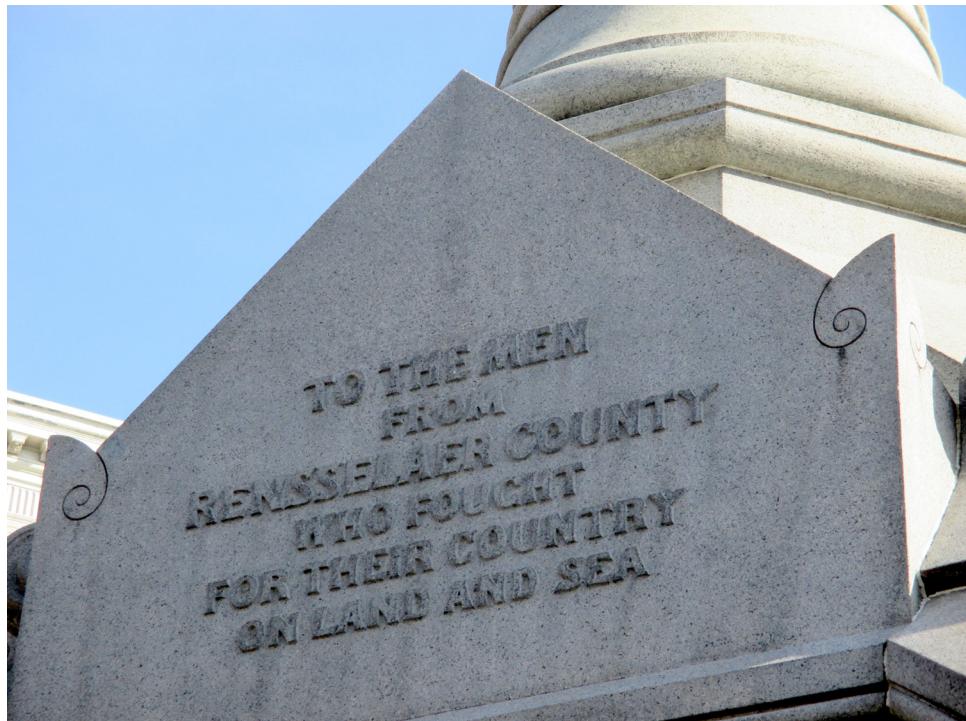
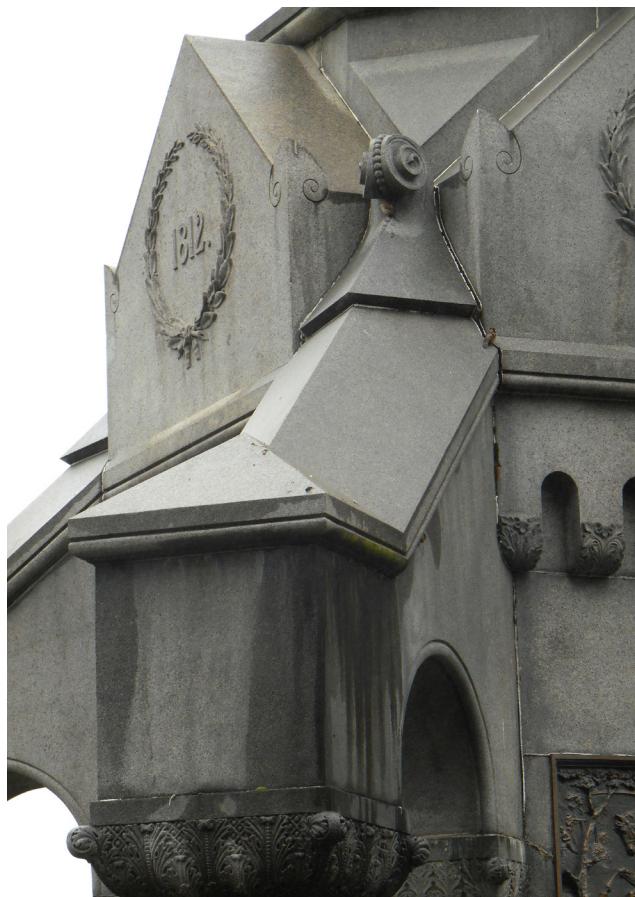
Between the colossal columns that supports the main statue and the Romanesque base is a series of large granite blocks that form what is essentially the monument's roof. This transitional area is in a simplified classical Greek style with four peaked stones displaying garland wreaths. The upward-facing joints behind the scrolled volute that springs from the confluence of these abutting slopes are a likely source of much of the water ingress that has caused joint erosion and displacement of some blocks. The block at the east side of the monument is further displaced than its counterpart. JGWA, 2017.

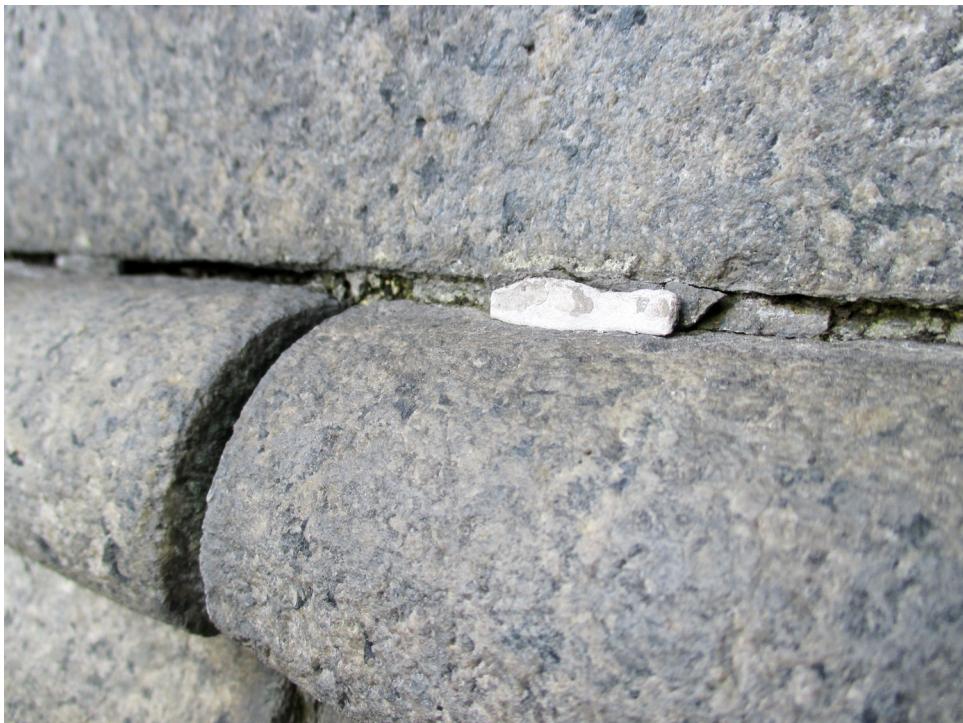
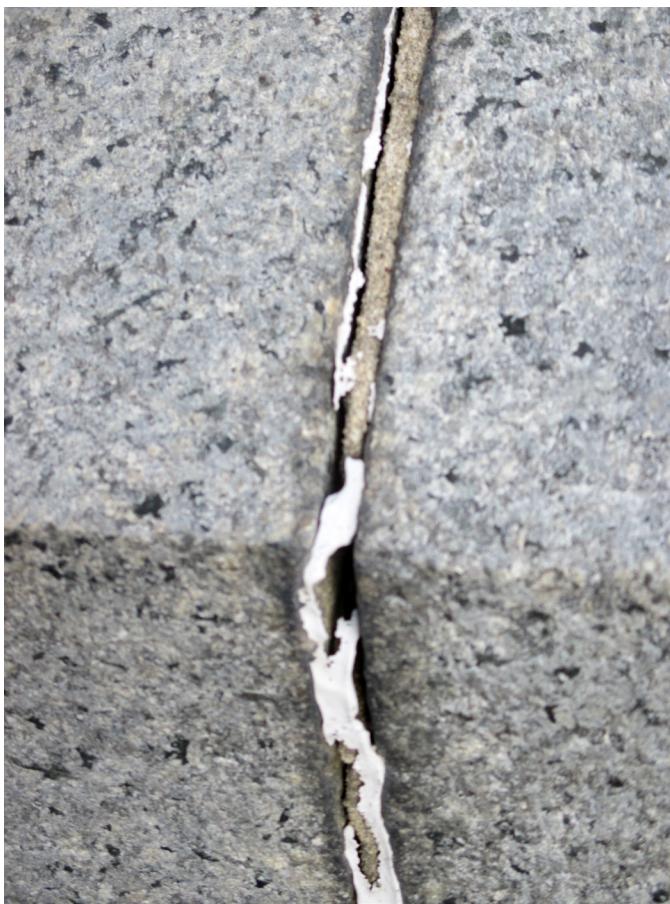
Open and deteriorated joints between individual units of masonry is the most significant, and widest spread, problem found at the monument. Some early mortar exists in places, but all of the joints have been filled, or covered with caulk, which is deteriorated, cracked, and missing in many locations. Torn caulk with intact but cracked mortar beneath is a sign of movement between stone units (left). JGWA, 2017.

- All existing mortar joints should be raked out and cleared of existing mortar and caulk in preparation for repointing. The properly prepared masonry joints should be filled with the mortar or caulk to be determined during mock-ups in the design phase. **\$45,000**

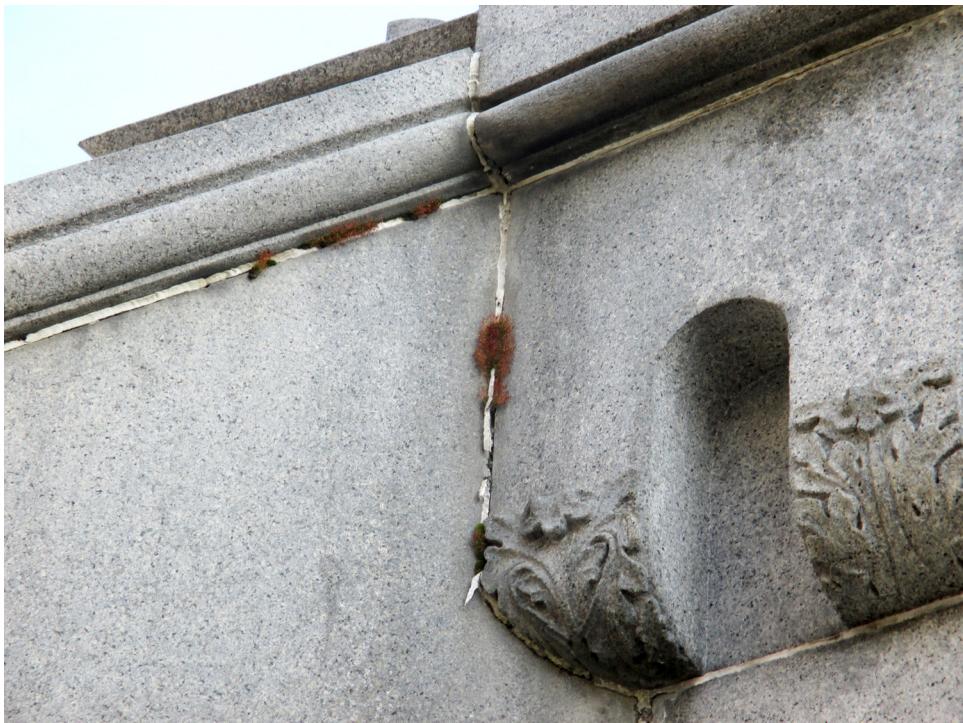
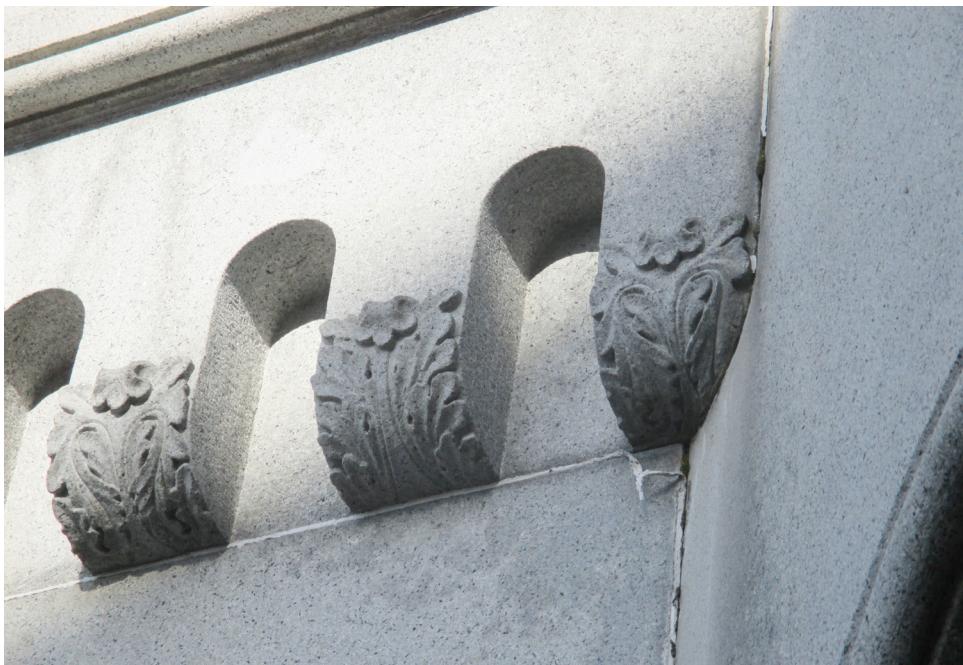
A single stone with a projecting arcade of five arches on integral corbels (known as machicolation) is located below each of the single-stone gables at the transition to the more Romanesque base of the monument. There are no joints within the single units; this condition forces water infiltrating from above to exit at the perimeter joints around these stones. The concentrated amount of water at these locations has led to failed mortar and caulk joints, as well as the moss growth shown in the upper photograph. JGWA, 2017.

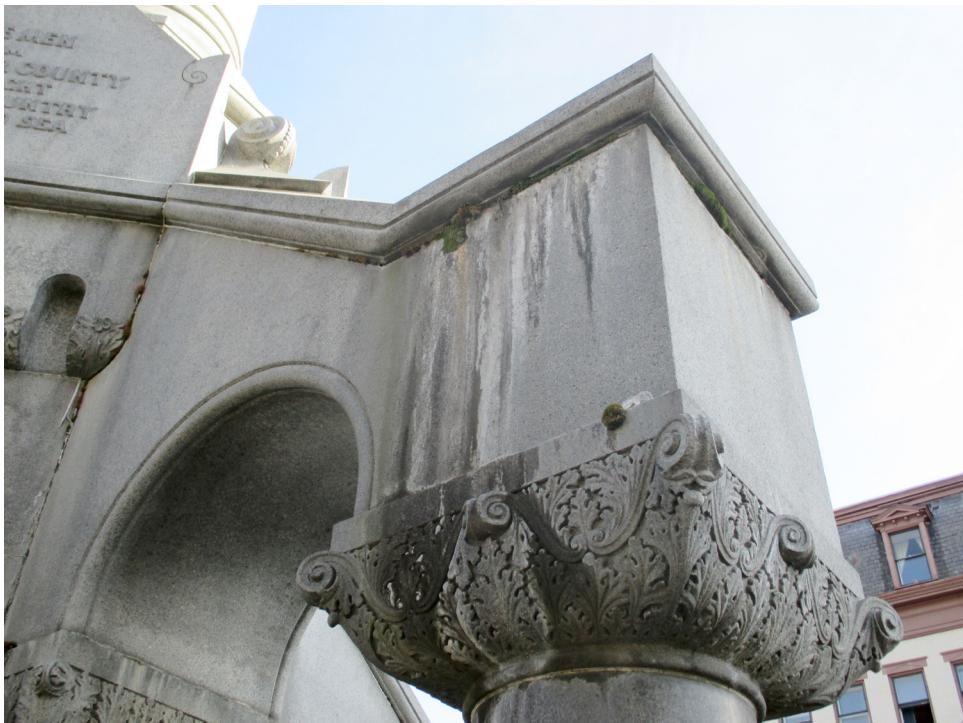
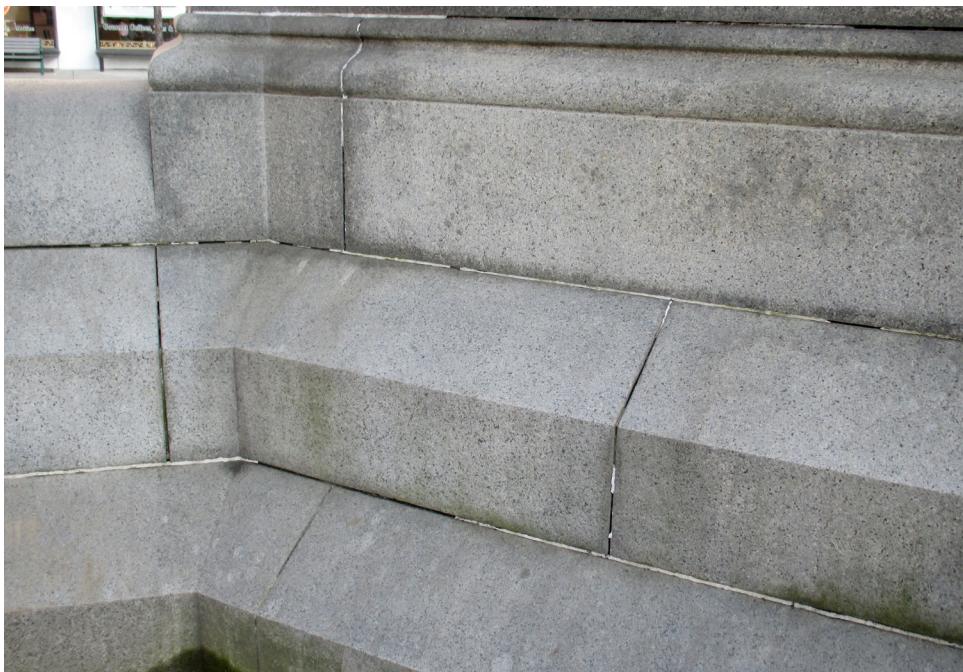
Virtually all of the joints at the monument are open, missing, or cracked. The limited number of joints between stones has meant that moisture that gets in at open joints exits at a limited number of locations. Many of these locations exhibit staining that is both chemical and biological in nature. Both of these types of stains can cause deterioration of the underlying substrate, and should be removed both for the appearance of the monument and for its long-term preservation. JGWA, 2017.

- Some upward-facing joints (particularly at the upper part of the monument's base) may be good candidates for metal "T" caps to produce longer lasting joints. **\$3,500**

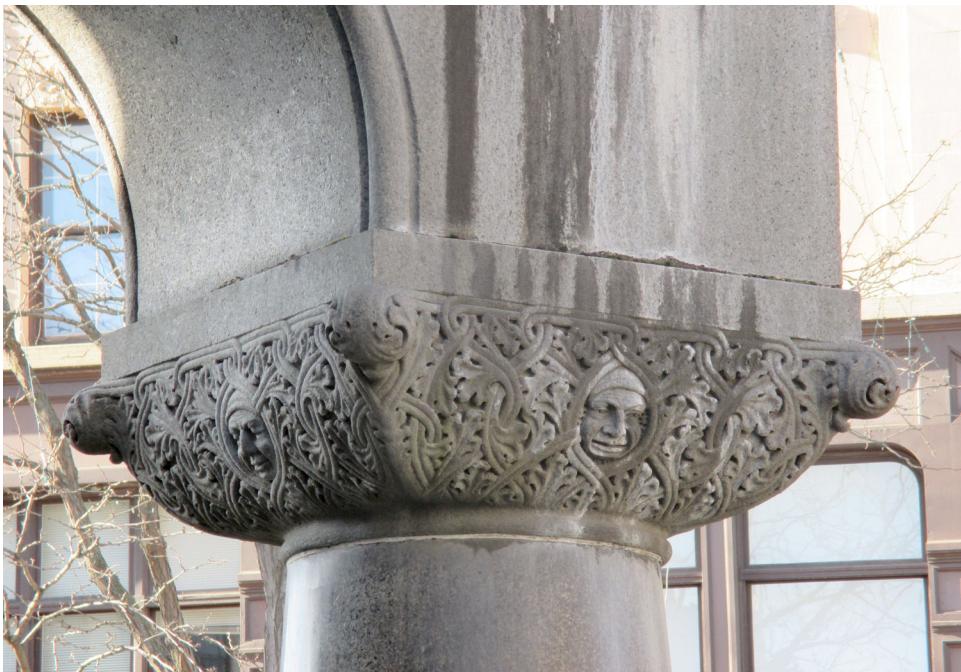
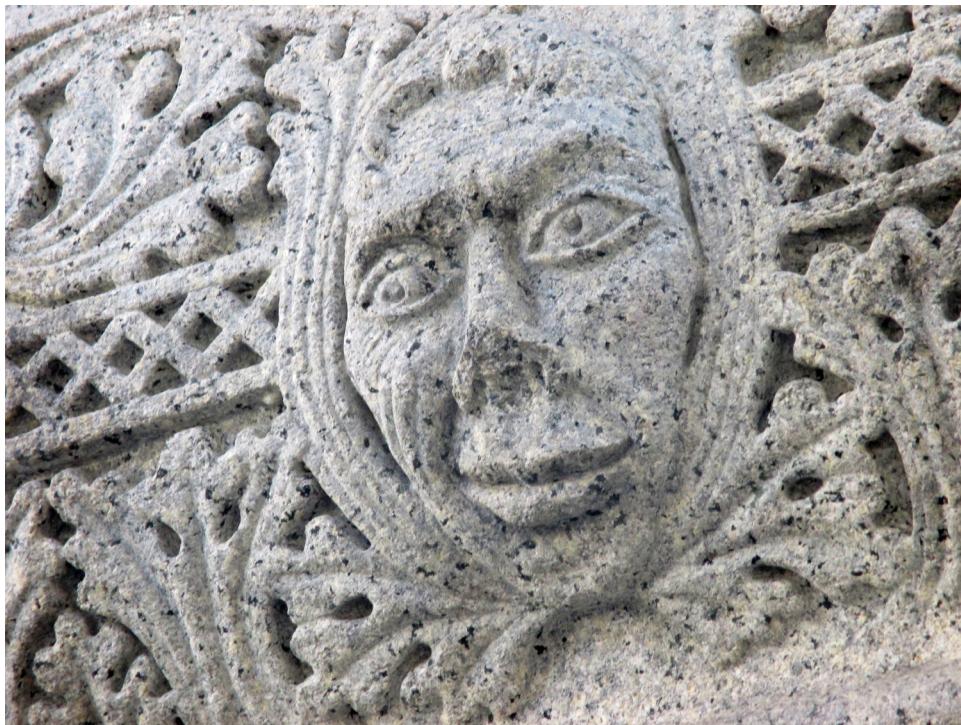
The four column capitals and four corresponding engaged pilaster capitals at the base of the monument exhibit the richest areas of carving of the entire structure. The joint above each has failed, but because each was carved out of a single unit of Quincy granite there is little opportunity for water ingress into the stone capitals, and all are in excellent condition. The nose of one of the carved faces (shown in the lower image) at the north side of the monument is missing as a result of impact damage (likely vandalism). All of the other carved surfaces of the capitals are intact. JGWA, 2017.

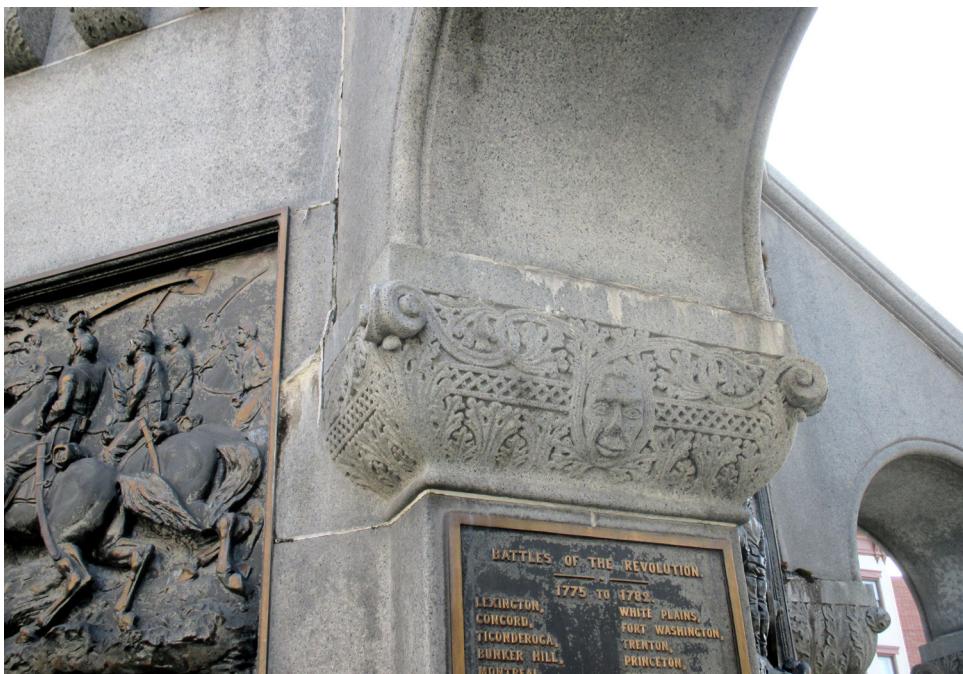
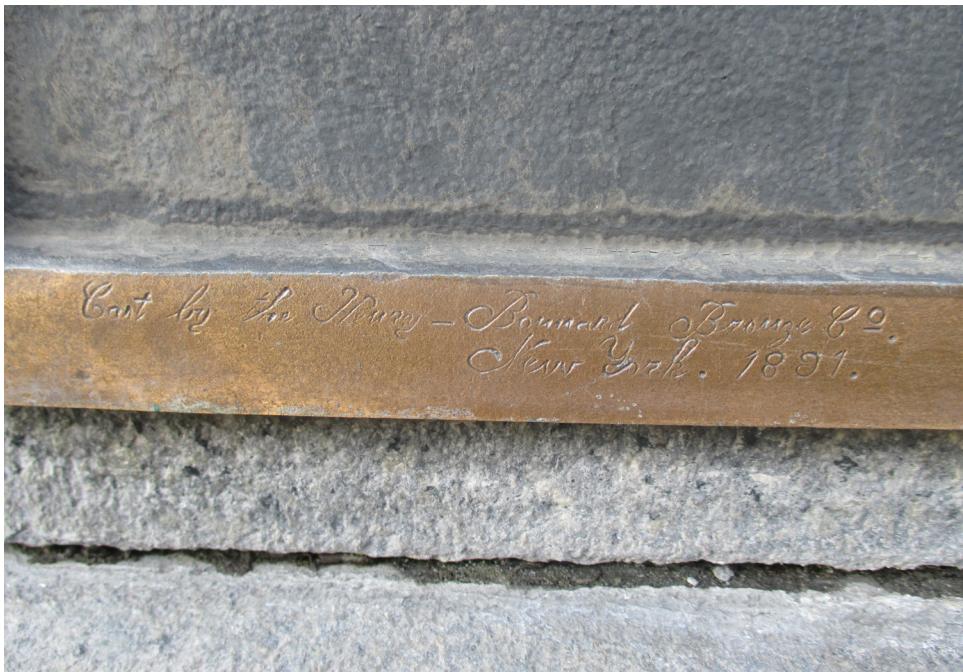
Each of the pilaster capitals are at the bottom of an "L" shaped block of granite. The upper leg of this block extends behind the large arched stones that span between each set of free-standing columns and their corresponding engaged pilasters. This condition has led to a crack forming where the lower part of the "L" and the leg have experienced differential movement. Lime scaling, from moisture based deterioration of the internal mortar, has leached through these cracks and formed a crust in most of these locations. The written plaque below the pilaster capitals were cast by Bonnard, and each displays the company's name in hand etched lettering (lower image). JGWA, 2017.

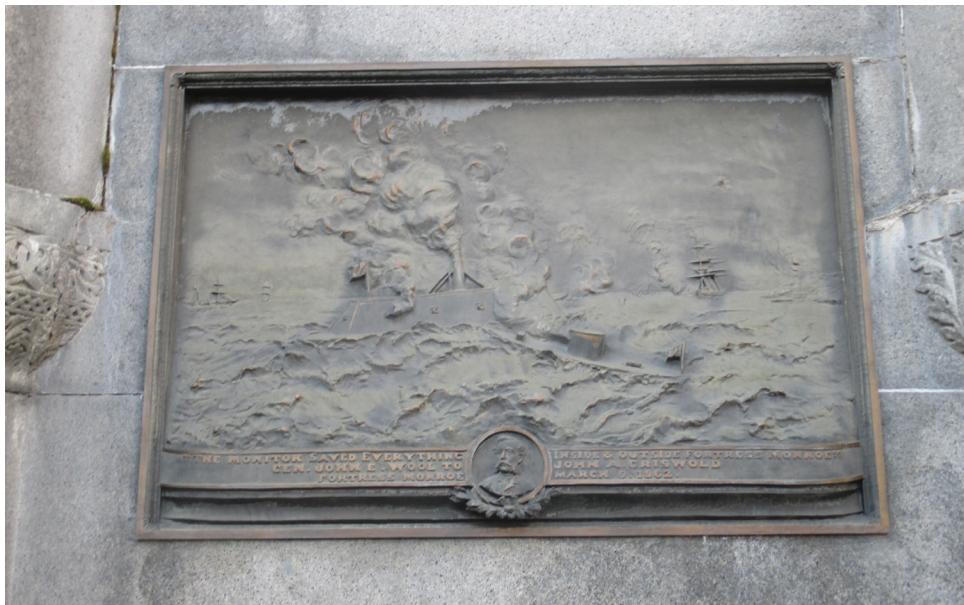
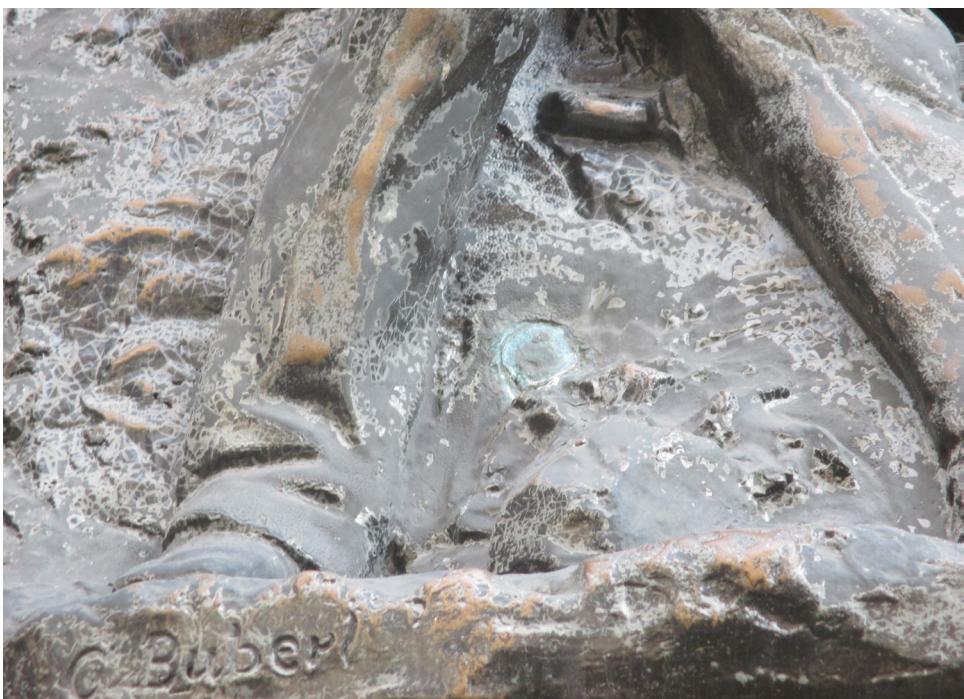
Of the eight bronze plaques at the base of the monument, four are well detailed alto-relief (high relief) depictions of scenes from the Civil War. Four smaller plaques have written inscriptions on them. Both types were produced by the Henry-Bonnard Bronze Co. in New York City. A smaller ninth plaque is located at the north side of the monument. Water appears to have gotten behind the larger, more decorative plaques and caused damage to the granite below. This water infiltration appears to have also caused rusting to the concealed anchors that fix the panels in place. In some places the exact location of these fasteners can be seen because the concealed bronze plug has broken loose at the head of the anchor. JGWA, 2017.

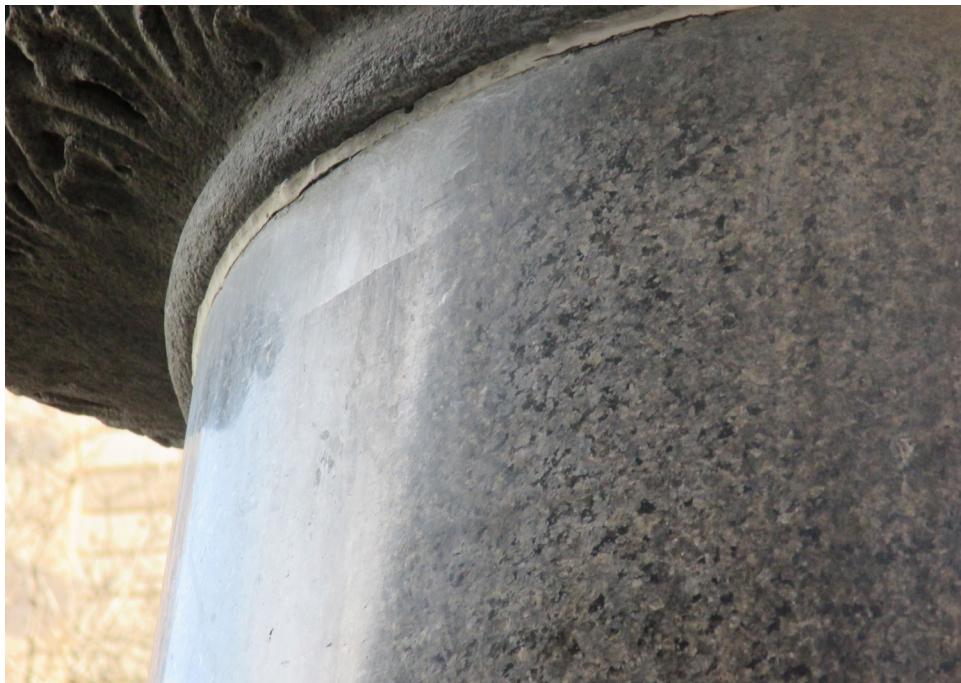
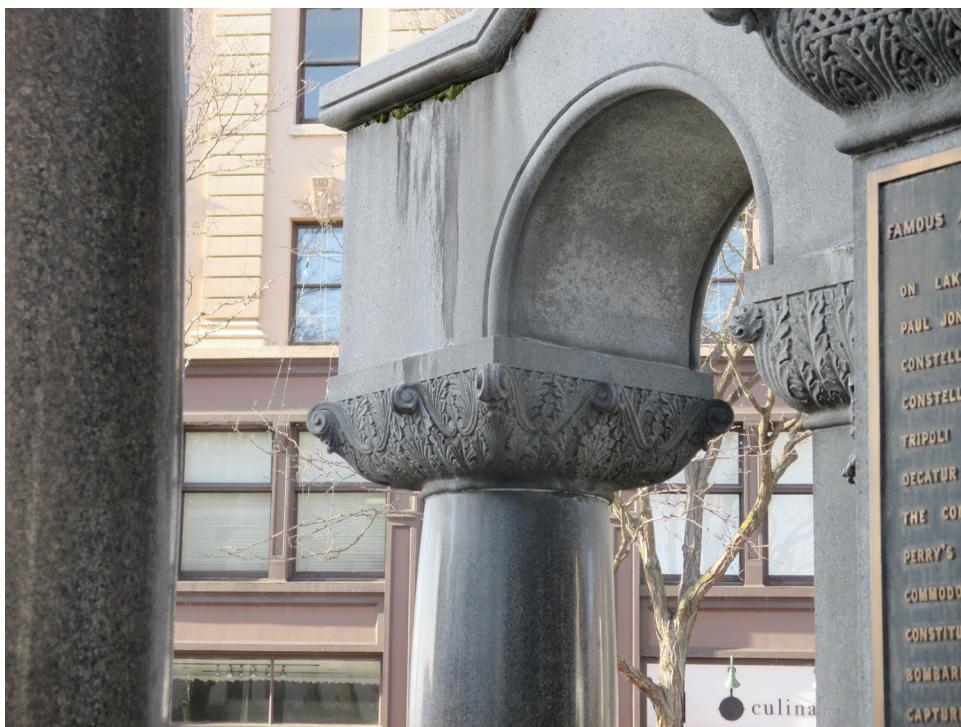
The unfluted shafts of the four columns that surround the monument are a highly polished granite (most likely Quincy granite); the difference in color is a result of the high polish. These columns are, like their capitals and bases, in excellent condition. There is some surface staining towards the top of the columns. Like other areas of the monument this condition is a result of gypsum deposits on the stones. These areas may require re-polishing. JGWA, 2017.

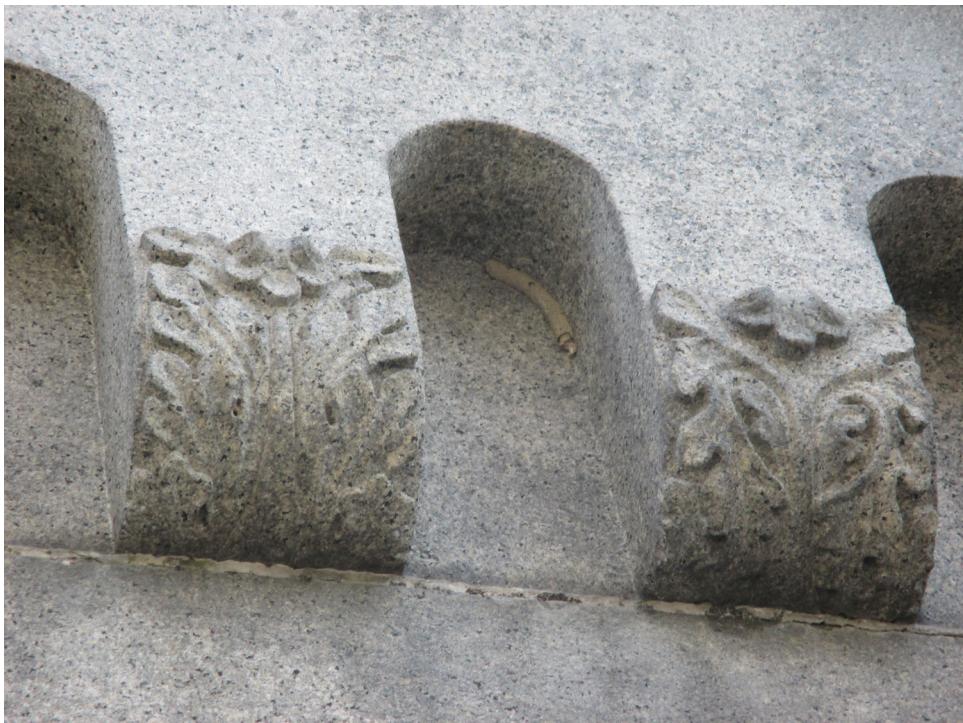
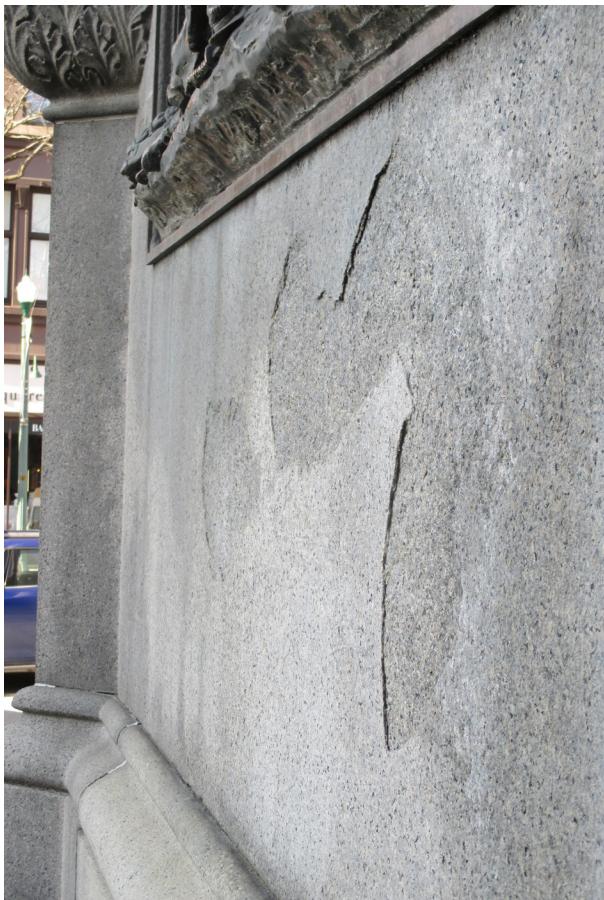
The Quincy granite that makes up the majority of the monument is in excellent condition, but some problems do exist. These problems range from the harmless nests of mud wasps (above), which cause no harm to the underlying material but are unsightly; to the four areas of spalled granite below the alto-relief plaques. Spalling of the granite face of the stone can only be seen immediately below the panels. This condition is likely the result of the masonry shelf below the plaques, which may allow water to enter the stone and spall the surface as a result of salt migration and freeze thaw cycling. JGWA, 2017.

- The monument's granite exterior should be carefully cleaned to remove all existing biological growth and other surface contaminants. **\$42,000**
- All areas of lime scaling and gypsum crusts should be specifically treated during the cleaning process based on the technique identified during pre-construction testing. **\$10,000**

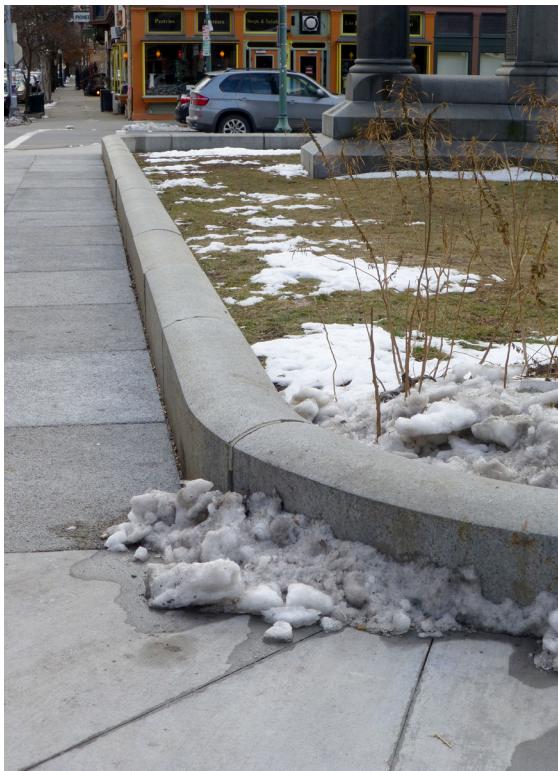
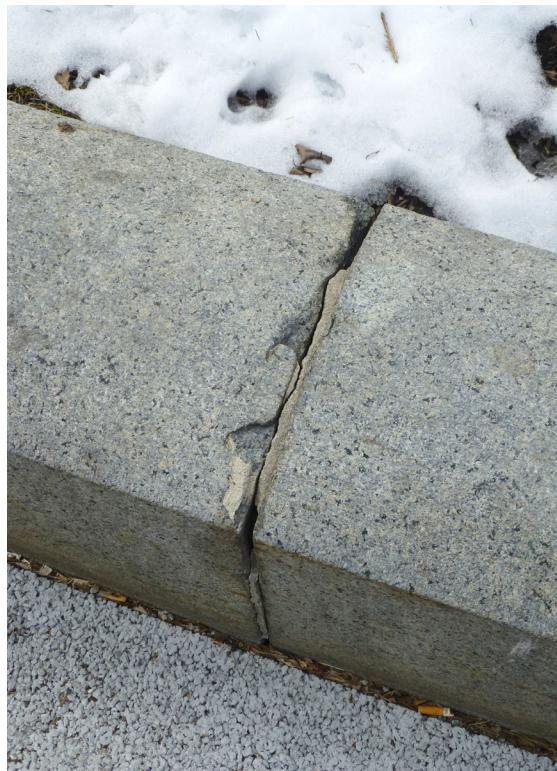
The site of the monument is surrounded by a high thick curb of Quincy granite abutting the municipal sidewalk. Some of the perimeter curbing has shifted out of its original position, and open or cracked joints exist between most of the units. In places, this shifting has caused chips and loss of material at the upper edges of some curbing stones.

- In conjunction with the above work, limited paving for paths may be added, but should not abut the monument directly. **\$10,000 to \$40,000**
- The mortar joints in the granite curbing should be repointed, and the curbing should be lightly cleaned after repointing. Displaced curbing should be reset. **\$20,000**

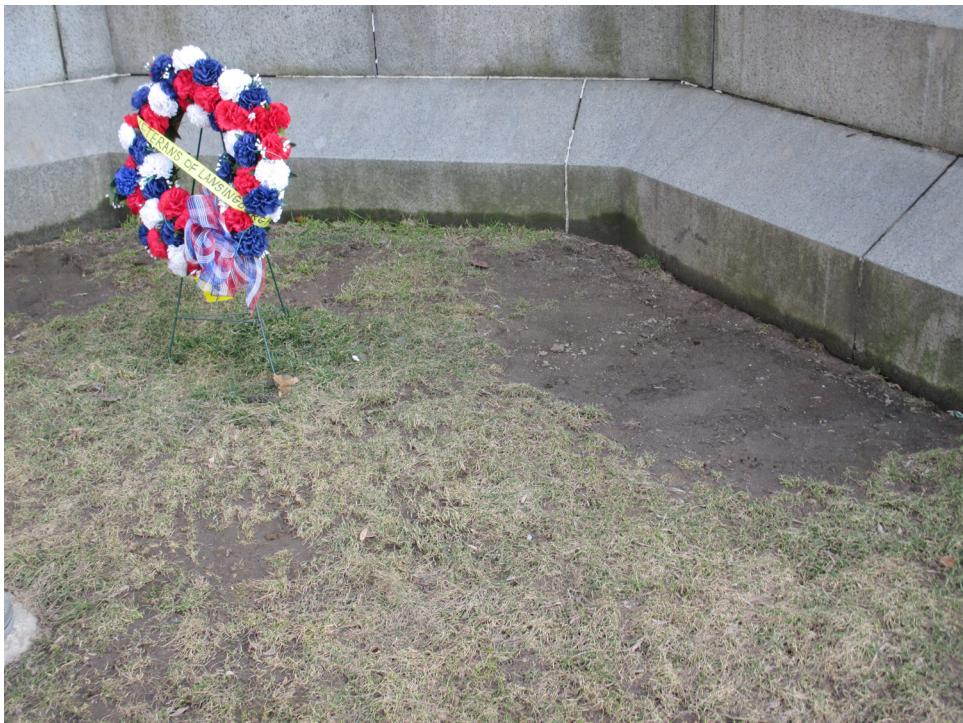
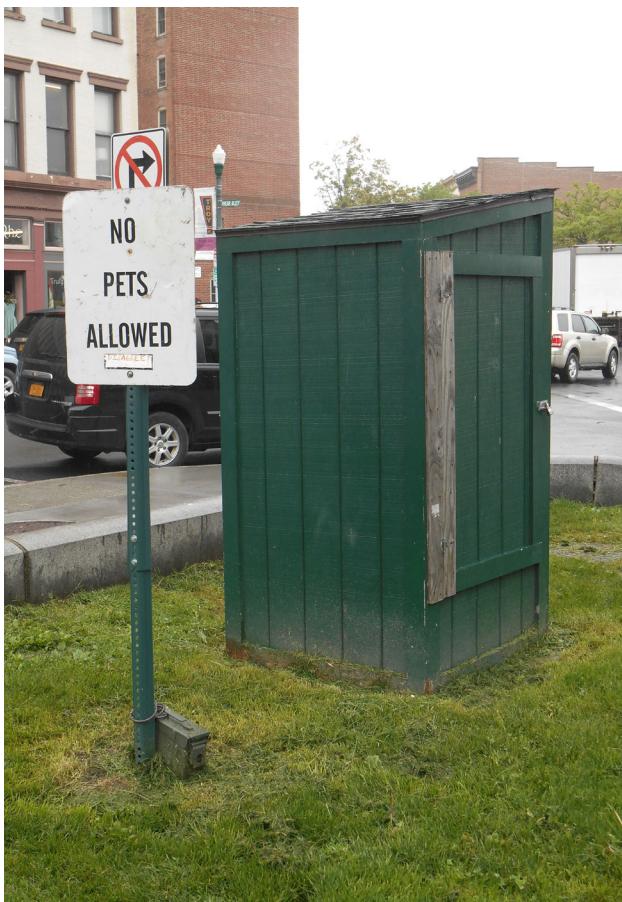
The space between the perimeter curbing and the base of the monument itself is covered in grass. Although this surface is worn in some areas, and can get muddy in some seasons, it has spared the monument from the type of salt damage that often accompanies paved surfaces that extend directly to the base of a structure. A large wood-framed utility booth (left) exists on the south side of the monument, and is an unsightly addition to the site. JGWA, 2017.

- The areas of lawn should be aerated and reestablished with a mix of grasses that are durable under high traffic situations. **\$2,500**
- The in-ground lighting should be updated to better illuminate the monument and utilize new technology that will conserve energy. **\$8,500**

- The existing wood-frame utility structure, located to the south of the monument, should be removed, and any required electrical infrastructure relocated to a small below-grade vault with an access hatch. **\$10,000**

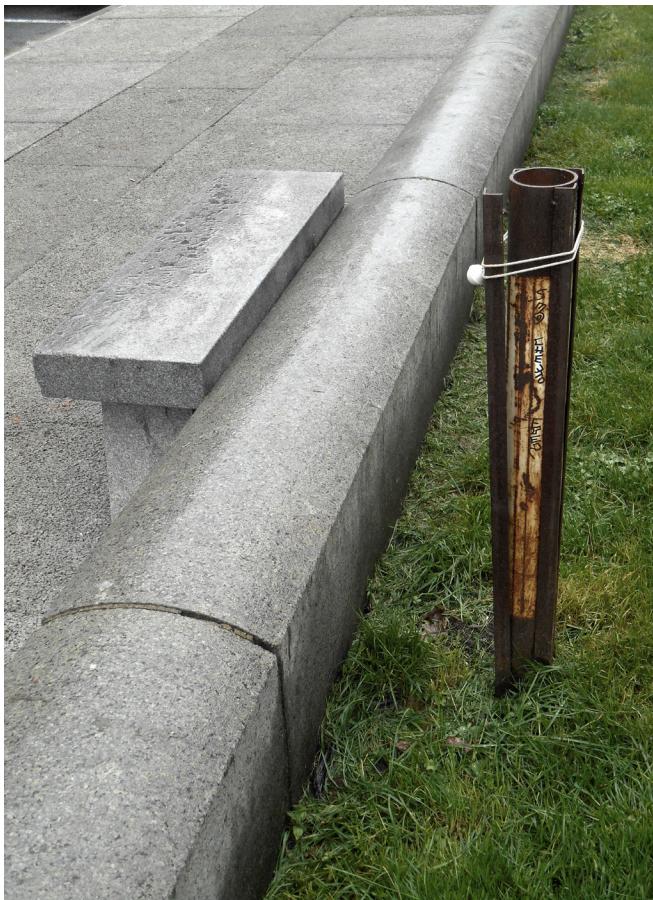
The bench on the west side of the monument, just outside of the perimeter curbing, is worn and damaged from skateboards sliding over the bench's outer edge. This is not the case on the curbing, which is of a similar height, because the slightly radiused top does not produce a sharp enough edge to allow for skateboard slides. A rusting metal post exists on the monument site adjacent to the bench. Four in-ground light fixtures that surround the monument are often filled with condensation. JGWA, 2017.
