September 19, 2018

**Subject: Recommendation for Lake Lowering, Ida Lake Dam Structural Inspection,
NYS ID: 226-1391**

Chris Wheland, Superintendent of Public Utilities
Ida Lake Dam Rehabilitation Project – Structural Inspection of Timber Spillway

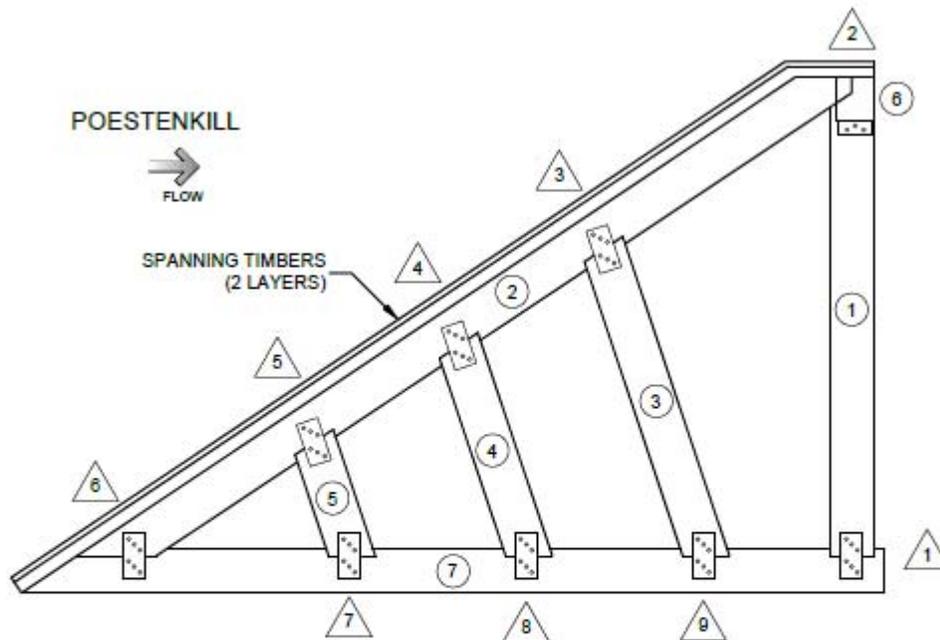
FIGURE 1 - TYPICAL CROSSWISE SUPPORTING STRUCTURE (BENT)

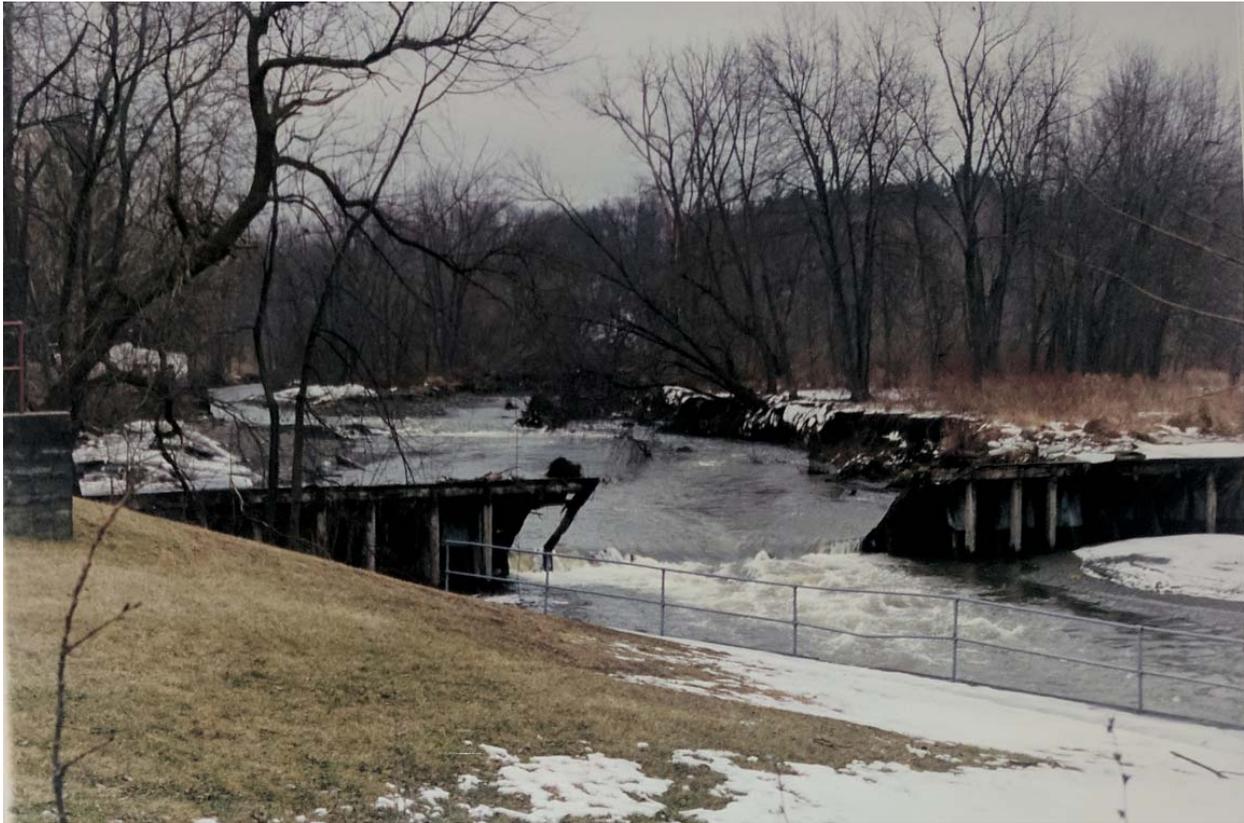
It is Schnabel's opinion that structural failure of spanning timbers will progress over the next 12 months within Bays F-13 and F-14, likely leading to a dam breach similar to the Ida Lake Dam failure that occurred in January 1999. An illustration of the 1999 breach is shown on Figure 2.

Figure 2: Previous Ida Lake Dam Breach, January 1999

To prevent another breach, we recommend taking emergency preemptive measures to lower the Ida Lake Pool level to minimize/eliminate the stresses on the dam. No mechanical means presently exist to implement this lake lowering; therefore, it would need to be accomplished by contractor intervention likely resulting in the full or partial removal of the most deteriorated Bays F-12 through F-16.
