NEW YORK STATE DEPARTMENT OF ENVIRONMENTAL CONSERVATION

Re: Ida Lake Dam, DEC ID# 226-1391
Troy (C), Rensselaer County
Class A – Low Hazard Dam
Condition Rating: “Unsound – Deficiency Recognized”

Visual Observations

<i>DAM NAME</i>	Ida Lake Dam				
<i>STATE ID</i>	226-1391	<i>SECTION</i>	A	<i>HAZARD CODE</i>	A
<i>COUNTY</i>	Rensselaer			<i>INSPECTION DATE</i>	9/28/2018
<i>NEAREST DS CITY/TOWN</i>	Troy			<i>INSPECTOR(S)</i>	TEB/JZS
<i>OWNER'S NAME</i>	CITY OF TROY				
<i>DOWNSTREAM HAZARD</i>	Low			<i>TOWNSHIP</i>	City of Troy

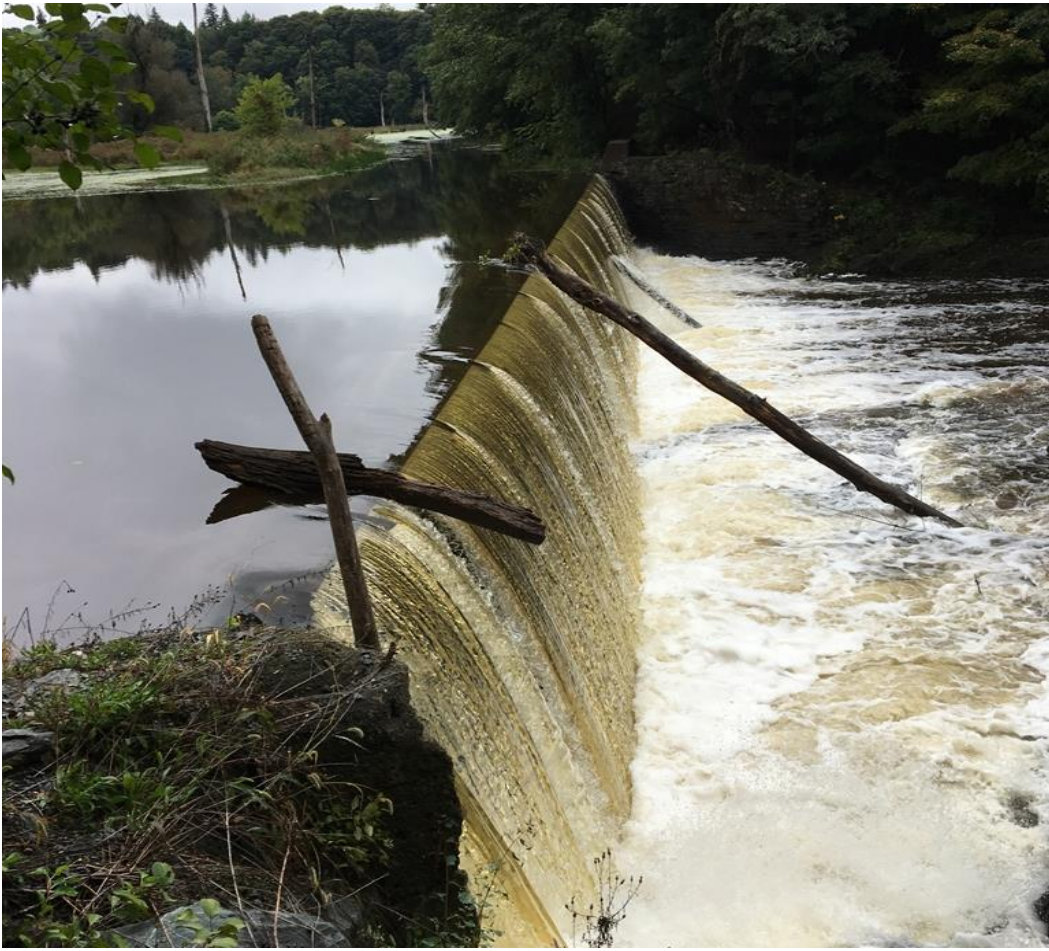
Photo 1 Dam ID# 226-1391 Ida Lake Dam 09/28/2018
Dam crest looking toward the left abutment

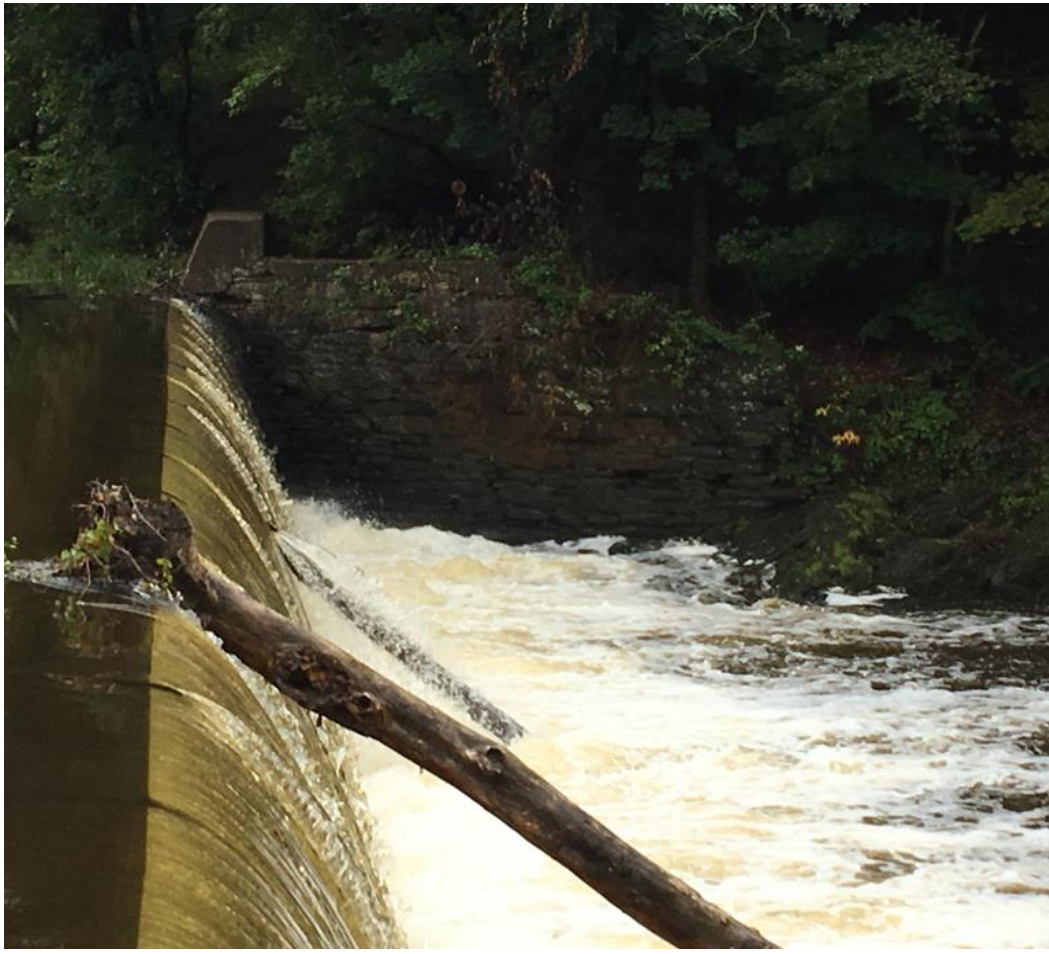
–Voids in the left and right abutment walls and right wing wall. Vegetative growth within and around the right masonry section. The left side was not accessed for inspection.

Photo 2 Dam ID# 226-1391 Ida Lake Dam 09/28/2018
Left abutment wall

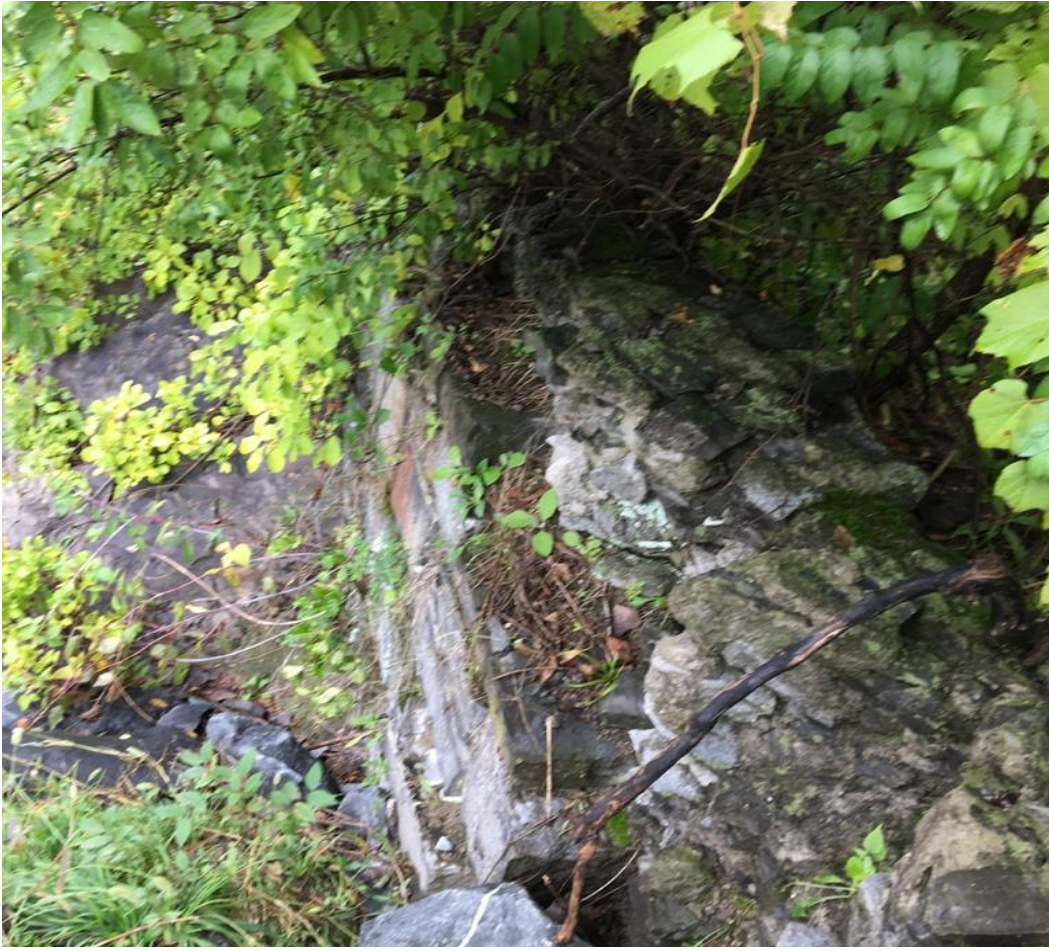
Photo 3 Dam ID# 226-1391 Ida Lake Dam 09/28/2018
Right downstream abutment wall looking downstream

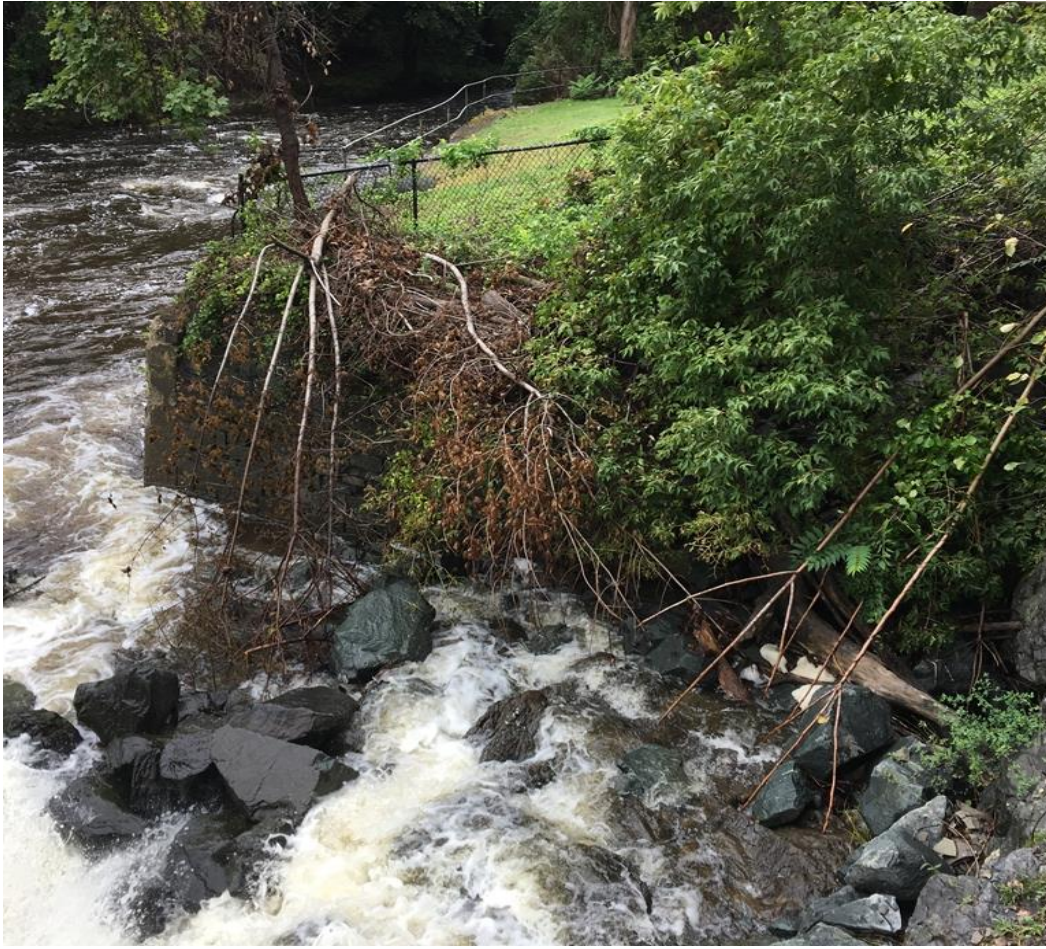
Photo 4 Dam ID# 226-1391 Ida Lake Dam 09/28/2018
Right downstream wing wall
