THE RENSSELAER COUNTY
SOLDIERS AND SAILORS
MONUMENT
MONUMENT SQUARE, TROY, NEW YORK

EXISTING CONDITIONS
ASSESSMENT

May 2017

John G. Waite Associates, Architects PLLC
384 Broadway, Albany NY 12207
64 Fulton Street, Suite 402, New York, NY 10038

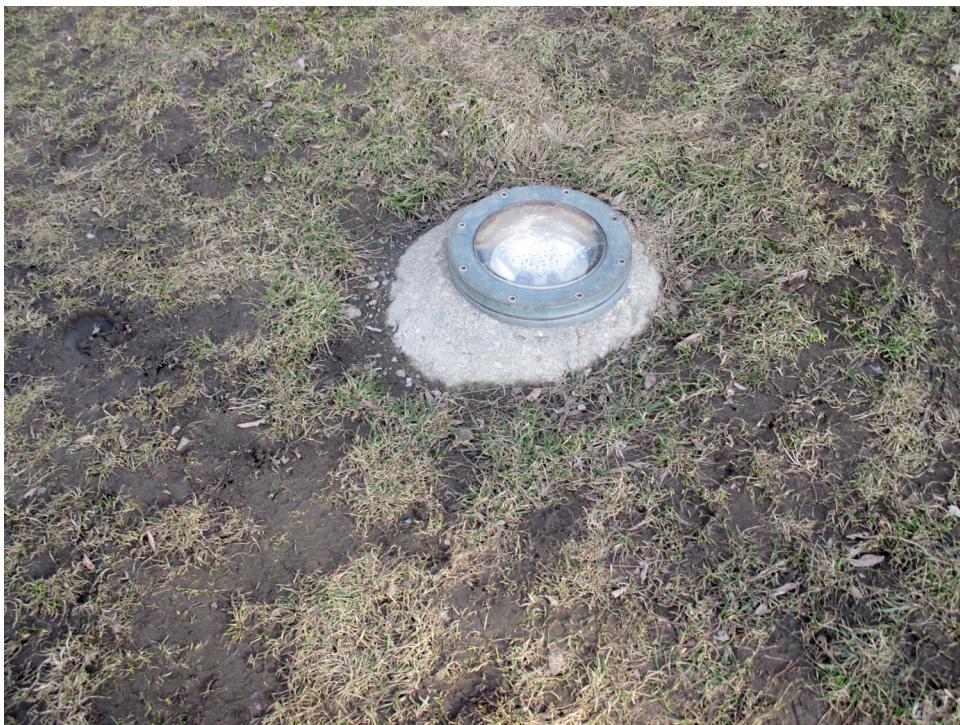
The bench on the west side of the monument, just outside of the perimeter curbing, is worn and damaged from skateboards sliding over the bench's outer edge. This is not the case on the curbing, which is of a similar height, because the slightly radiused top does not produce a sharp enough edge to allow for skateboard slides. A rusting metal post exists on the monument site adjacent to the bench. Four in-ground light fixtures that surround the monument are often filled with condensation. JGWA, 2017.
